PRODUCT CASE STUDY

Solar panel charging station for electric vehicles experienced a fire hazard, to which Firefighters were summoned.

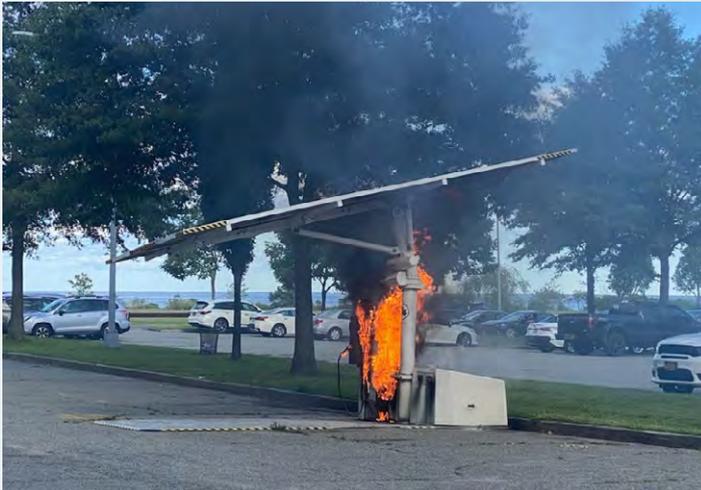
1 Solar EV charging station fire

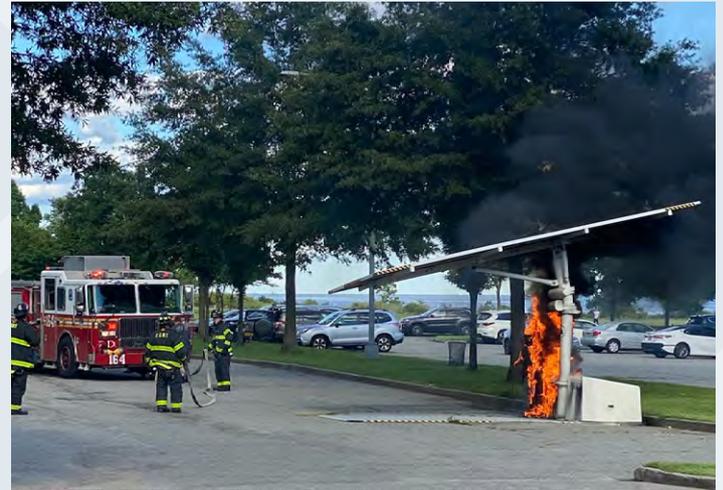
2 Water not effective - fire re-ignites

Firefighters attended and their first attempt to extinguish the fire was with water (safe distance and applied water pressure to ensure safe approach to an electrical fire).

They managed to extinguish the fire, but within a very short time period the fire re-ignited.

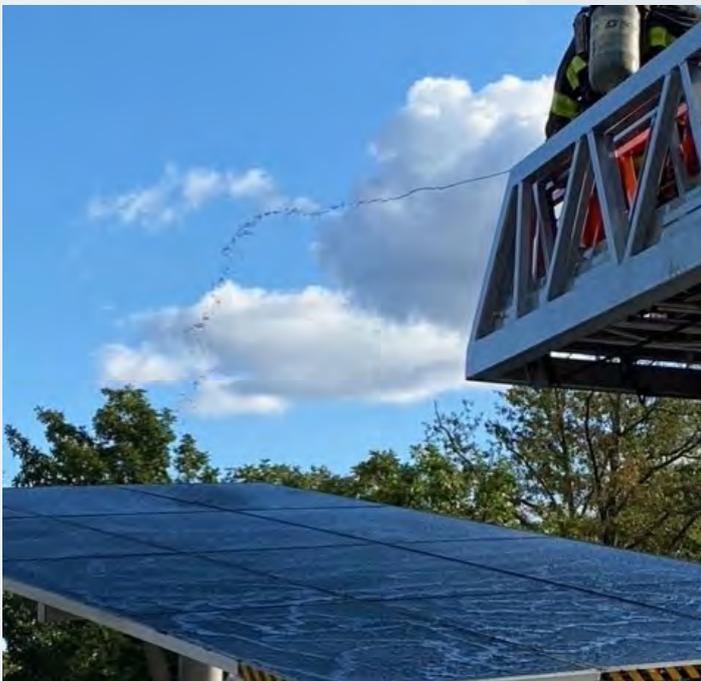
3 PVSTOP applied

The Firefighters realised that they were not focused on the source of the ignition, which was the sunlight on the panels feeding the electrical fire, and they requested PVSTOP.

PVSTOP was applied successfully to the panels, covering them and de-energising the solar system.

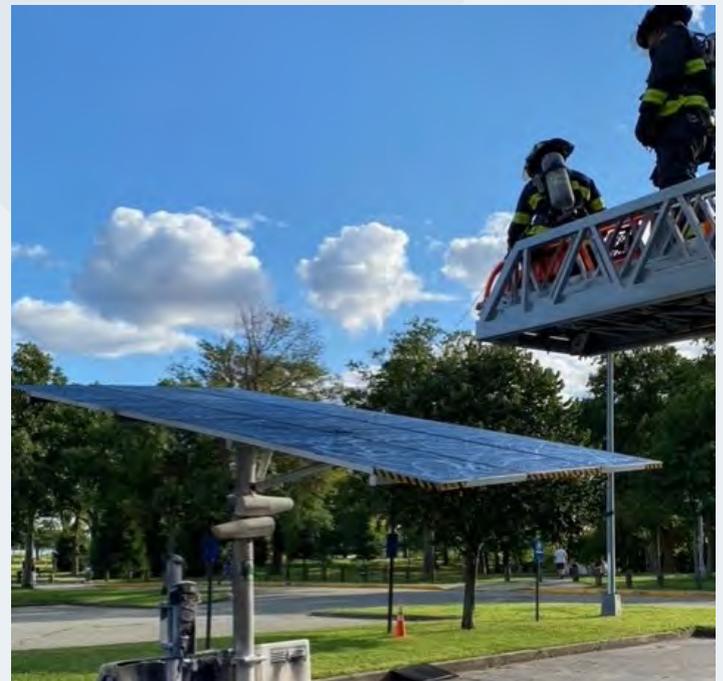
4 Solar system de-energised and fire controlled

At this point, the fire was manageable and safely extinguished.
